SUBJECT: Operational Report-Lessons Learned (RCS CSFOR-65), for Quarterly Period Ending 31 January 1967.

a. During the quarter November 1966 through January 1967, the 19th Engineer Battalion's role and main mission changed from combat support to construction. The combat support operations Thayer, Tiger Hound, and MANG HO were terminated and the battalion undertook construction projects in support of the development of the Qui Nhon area. This transition, while deliberate and smoothly conducted, required readjustment from operational support to construction operations. Long range planning replaced expediency, scheduling replaced on-hand capability, and a constant job effort was necessary rather than the hasty short term mission requirement of combat support roles.

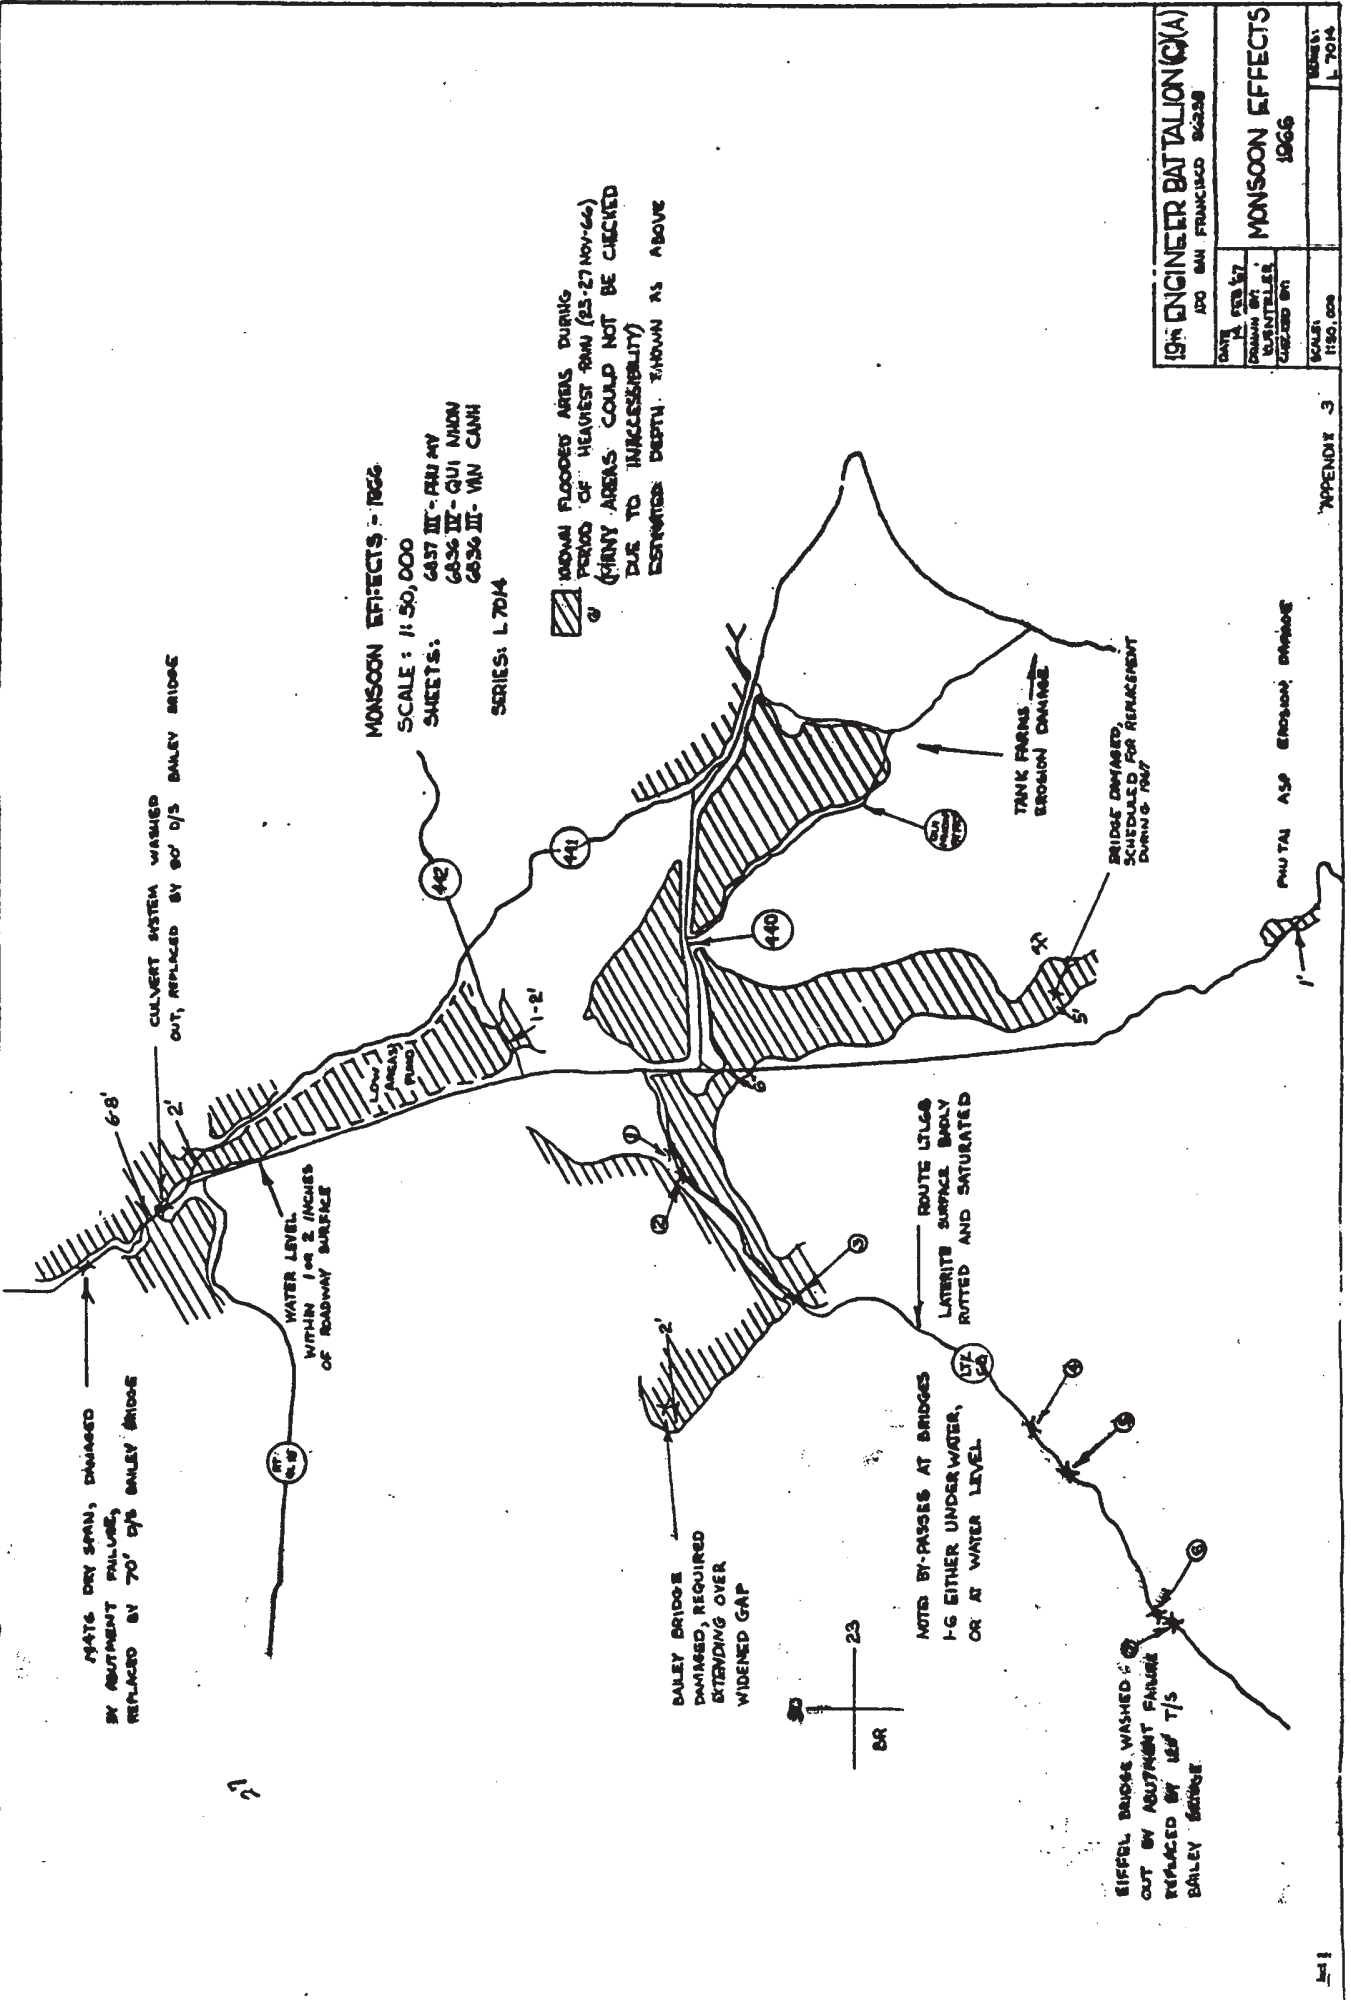
Incl 1

74'6" DRY SPAN, DAMAGED BY ABUTMENT FAILURE, REPLACED BY 70' D/S BAILEY BRIDGE

CULVERT SYSTEM WASHED OUT, REPLACED BY 90' D/S BAILEY BRIDGE

BAILEY BRIDGE DAMAGED, REQUIRED EXTENDING OVER WIDENED GAP

TANK FARMS EROSION DAMAGE

BRIDGE DAMAGED, SCHEDULED FOR REPAIR DURING 1967

STEEL BRIDGE WASHED OUT BY ABUTMENT FAILURE, REPLACED BY 150' T/S BAILEY BRIDGE

PHU TAI ASP (EROSION) DAMAGE
